# Final Work Plan for Groundwater Baseline Investigation at U.S. Navy's Eastern Maneuver Area Viegues Island, Puerto Rico

# Department of the Navy Atlantic Division Naval Facilities Engineering Command

## CH2MHILL

September 6, 2001

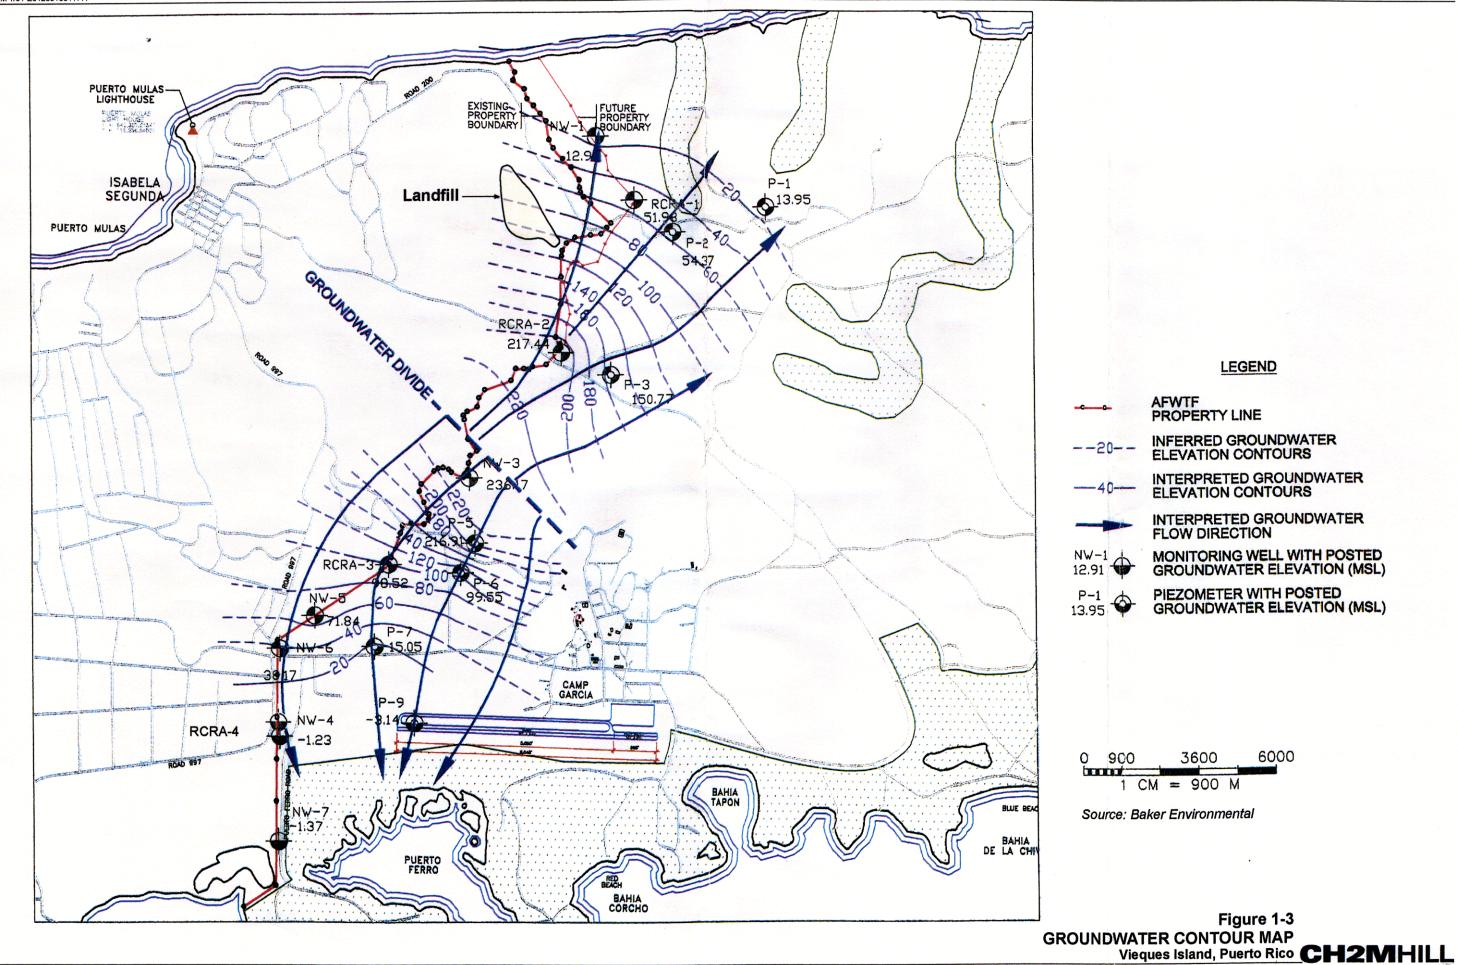
As part of the previous Hydrogeologic Investigation, groundwater elevation measurements were recorded on August 26, 1999 and are presented in Figure 1-3. The depth to groundwater within the bedrock ranged from approximately 36 feet at NW-5 to 131 feet at P-1. The groundwater elevations of the bedrock are significantly higher than the elevations where groundwater was encountered during drilling. This would indicate that the bedrock formation is under artesian conditions. The groundwater elevation data for the bedrock indicates that a groundwater flow divide exists within the bedrock at the approximate north/south mid point of the island: at the location of well NW-3 (see Figure 1-3). Generally, groundwater north of well NW-3 flows north toward the Atlantic Ocean and groundwater south of NW-3 flows south toward the Caribbean Sea.

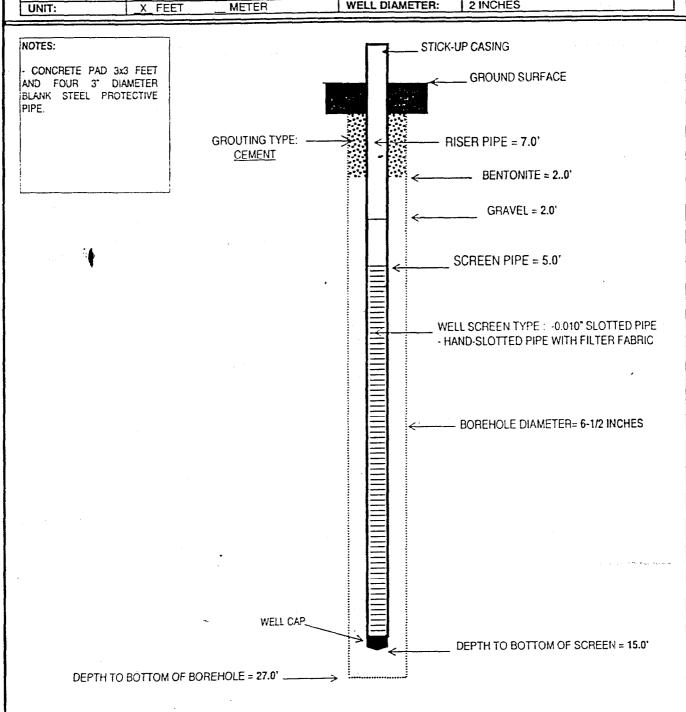
- CONCRETE PAD 3x3 FEET AND FOUR 3" DIAMETER BLANK STEEL PROTECTIVE PIPE.

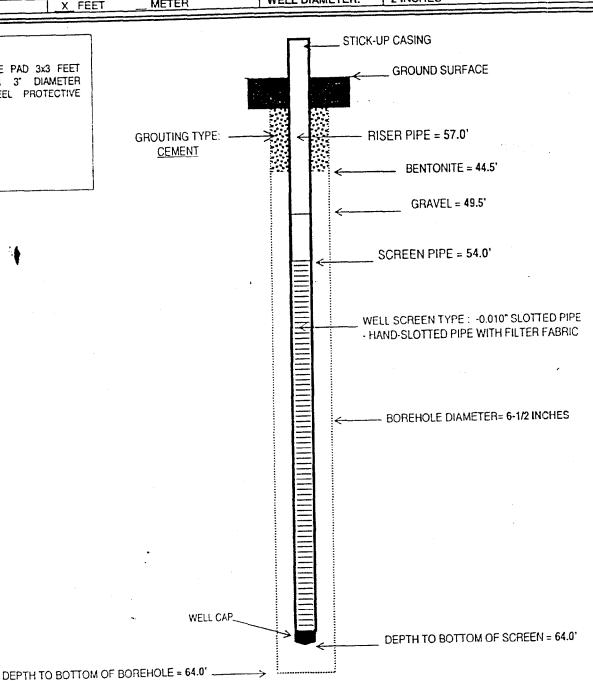
# WELL CONSTRUCTION DETAIL

- CONCRETE PAD 3x3 FEET AND FOUR 3" DIAMETER BLANK STEEL PROTECTIVE PIPE.

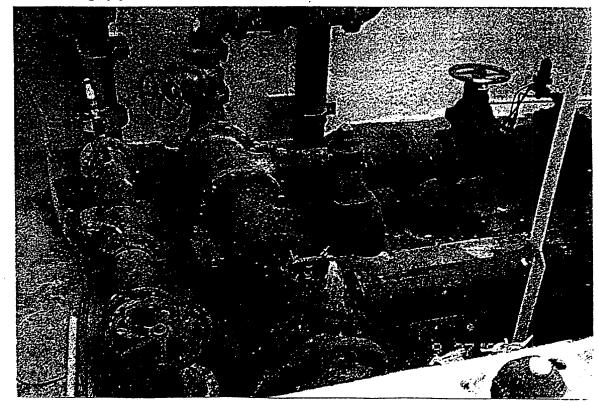
Photo #2: Arcadia tank - Chlorine is added to the intake pipe (on the left). The sample was taken from the discharge pipe (on the right, with the tap open).

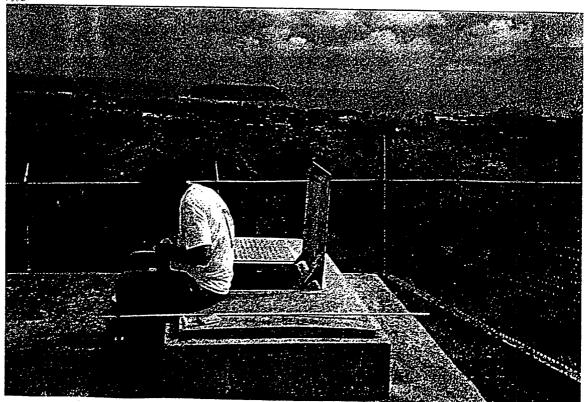
Photo # 4: Esperanza tank showing access hatch, and Esperanza in the background.
